NASA Technical Memorandum 104532
AIAA-91-2123

Microanalysis of Extended-Test Xenon Hollow Cathodes

MICROANALYSES OF EXTENDED-TEST XENON HOLLOW CATHODES

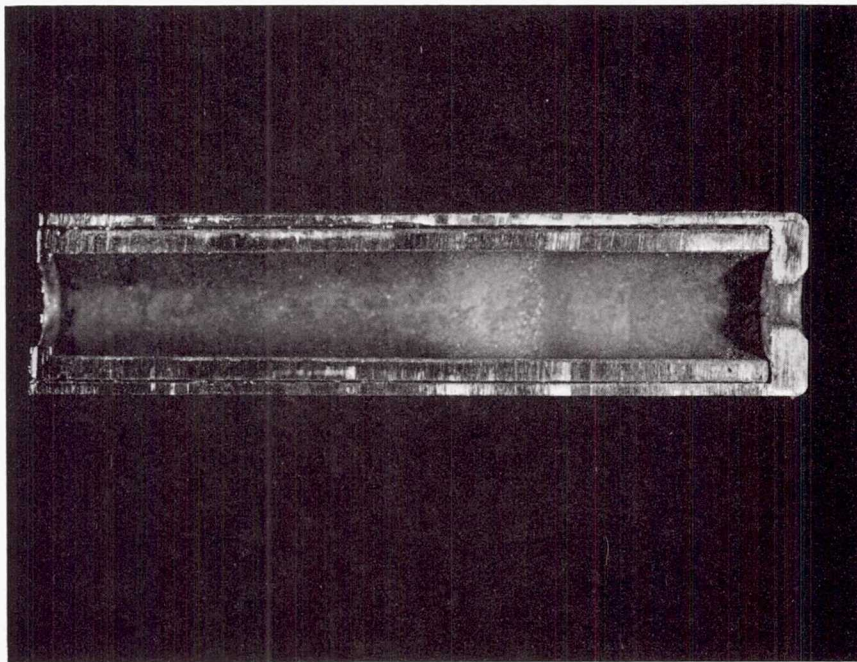
The inside of cathode WT-II is shown in Fig. 15(b). There appeared to be material deposited on the orifice plate

Figure 15. Sliced SBJ1 wear-test cathodes. Gas flowed from left to right.

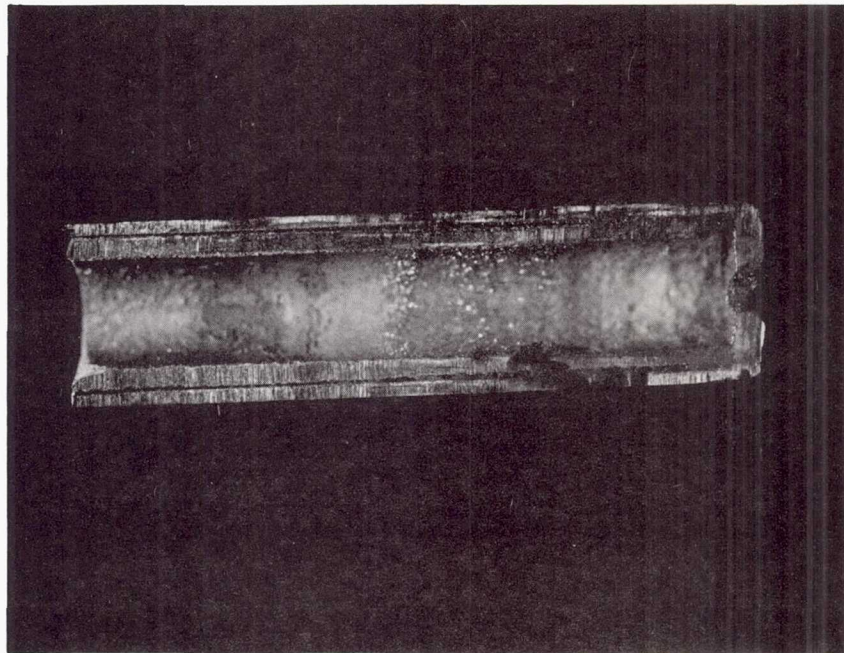
(a) TL-I Cathode

Figure 16. Sliced thruster life-test cathodes. Gas flowed from left to right.

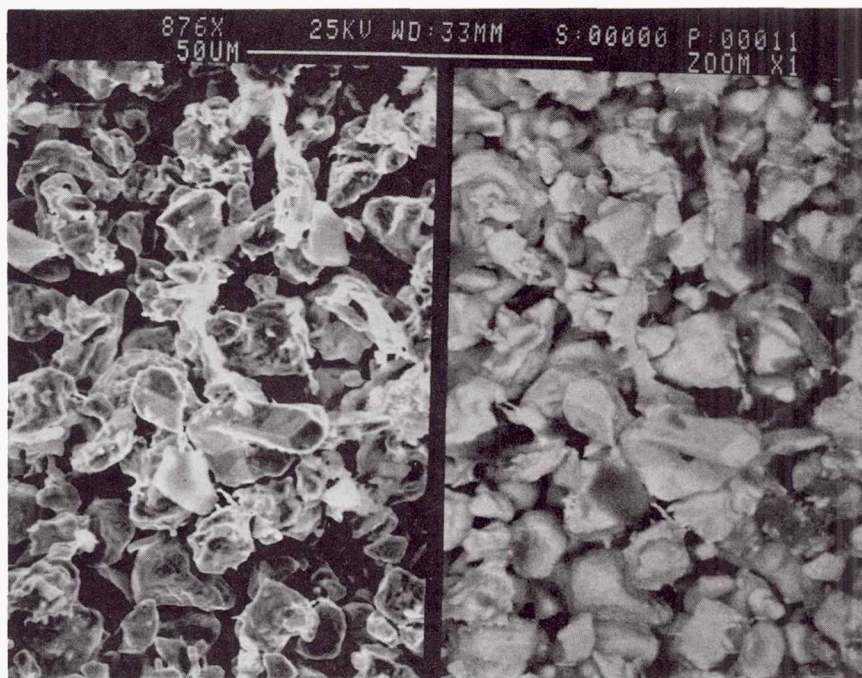
Figure 23. Surface of the second region of cathode WT-I insert, showing grain structures, SE image on the left and BSE image on the right.

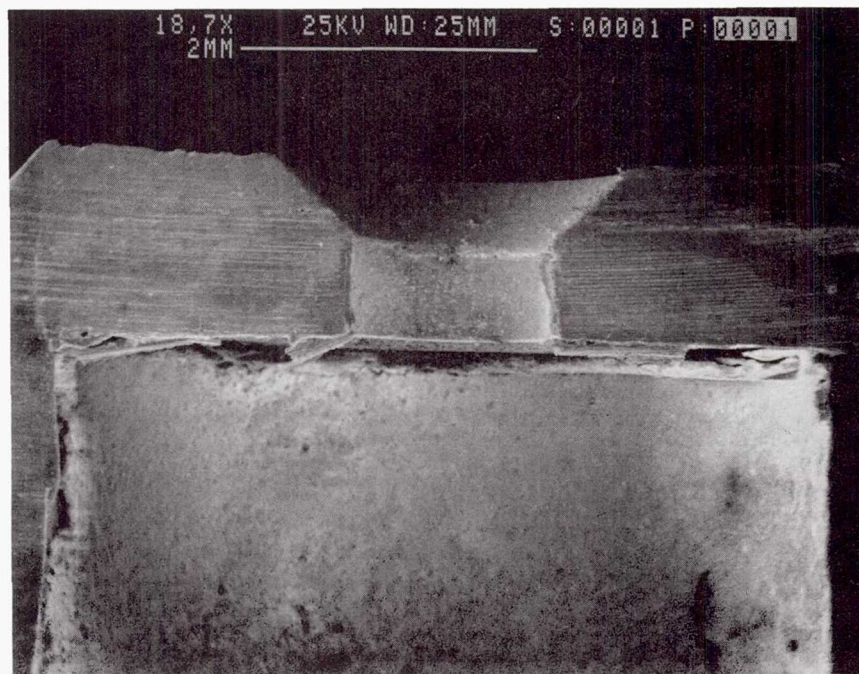
chamfer were in very good condition, showing no signs of change in size or shape. The surface of the orifice channel appeared similar to that of cathode WT-I, though the apparent deposition was not as heavy. Small amounts of barium and calcium were also found in the channel. Material deposition occurred in the area surrounding the orifice which looked similar to the deposition formation around the orifice of cathode WT-I, though not nearly as substantial. It formed a ring around the orifice with an inner diameter of approximately 1.9 mm and an outer diameter of 2.3 mm. EDS determined that it was tungsten metal with a trace amount of barium. The cathode tube wall and the insert were examined separately since the insert was removable. In Fig. 26, the photograph shows where the insert had been by the presence of material collected on the tube wall. This material was composed of barium, calcium, tungsten, oxygen, and aluminum with trace amounts of molybdenum and rhenium. The relative amounts of the elements in this compound were found to vary with location and surface geometry.

Figure 25. SE image of orifice of cathode WT-II. Propellant flowed from bottom to top.

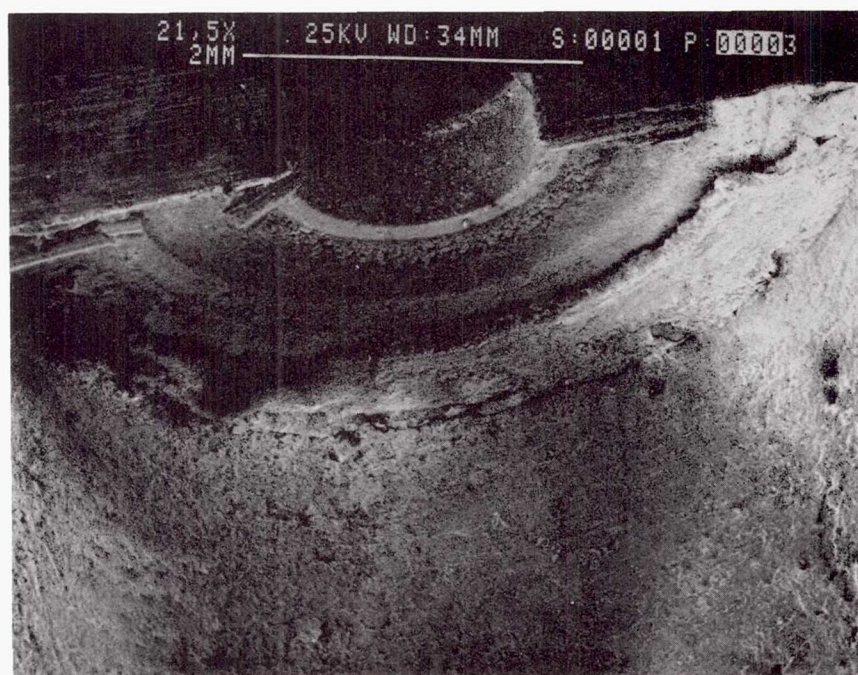
Figure 26. SE image of the inside of cathode WT-II tube without the insert. Propellant flowed from bottom to top.

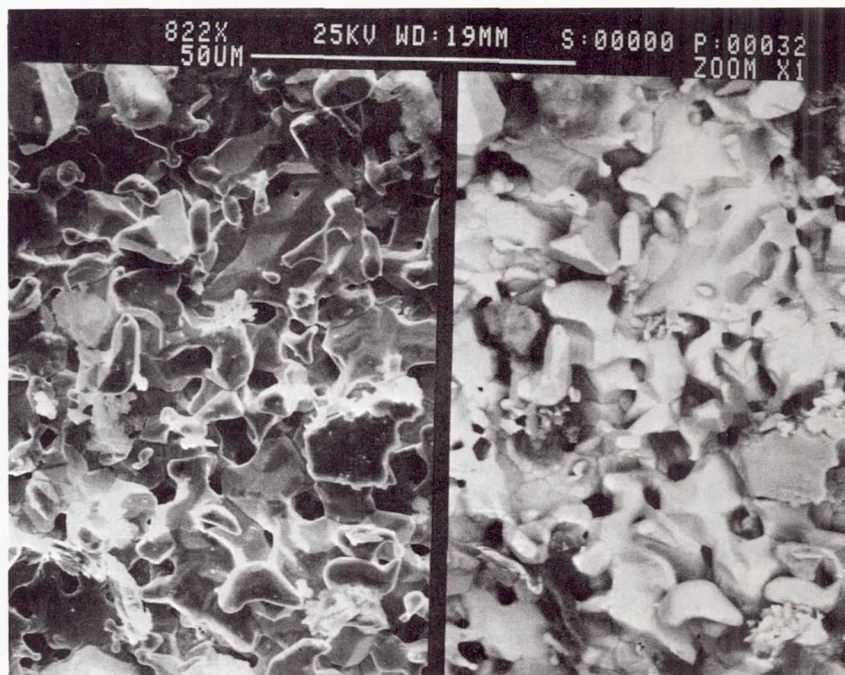
The insert surface condition was also found to be position dependent, with three distinct regions (see Fig. 18). The photograph in Fig. 27 shows the surface of the first region at the downstream end of the insert which had the structure of the sintered tungsten. Only tungsten was found in this region, indicating that all barium and its compounds had been removed from the surface during discharge operation. The second region, approximately 1.2 cm from the orifice plate, consisted of a darker band on the surface that was approximately 1.1 mm wide. The gray shading of the grains in the BSE image in Fig. 28 was a surface coating composed of tungsten, barium, calcium, oxygen, and trace amounts of aluminum and molybdenum. The white grains on top of the coating were tungsten. In the third region of the insert, the surface was also found to have a coating, though not as uniform as the second region, and which had much more material collected on top (Fig. 29). The coating, distinguished in the BSE image by the darker color, was composed of tungsten, barium, and trace amounts of calcium, aluminum and molybdenum, and was very similar to that of the second region though the signals for all elements other than tungsten were weaker. Oxygen was assumed to be part of this material. At the upstream end

Figure 27. Surface of the downstream end of cathode WT-II insert.

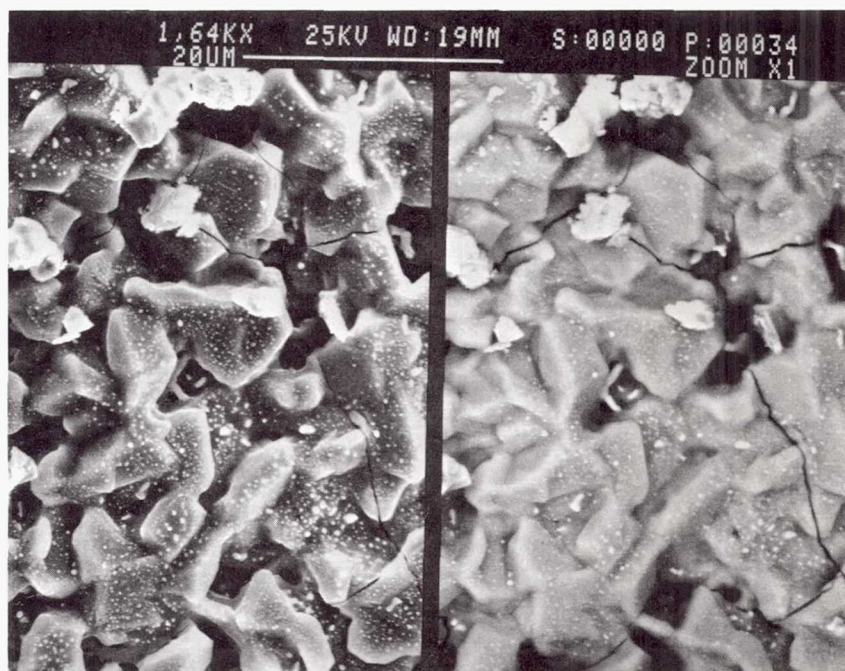
Figure 28. Second region on the insert surface of cathode WT-II.

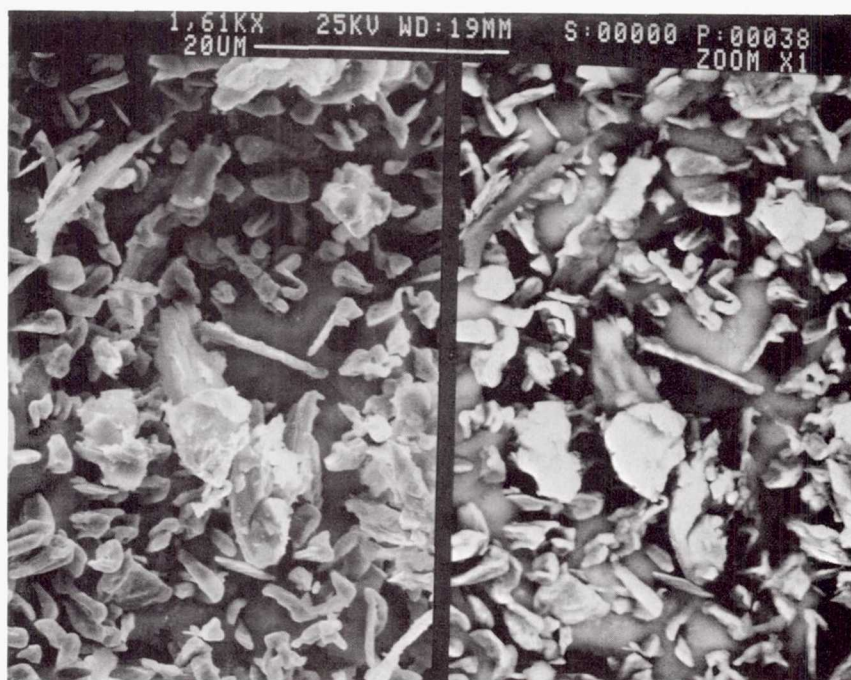
Figure 29. Surface of the upstream end of the cathode WT-II insert.

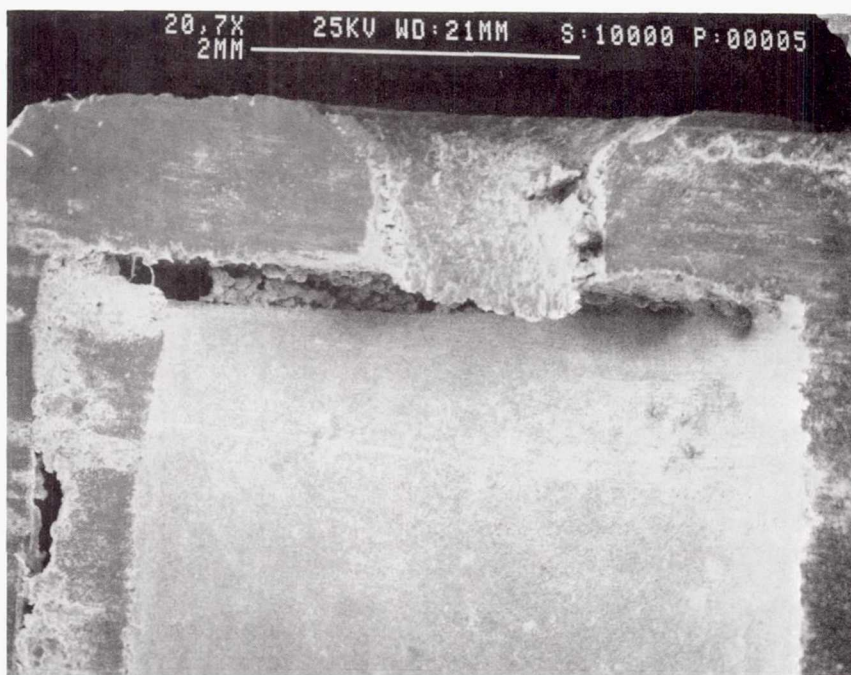
The orifice of cathode TL-I is shown in the photograph in Fig. 30, which confirmed that the chamfer was filled in and that material was deposited along the entire channel. The deposition extended the orifice channel into the cathode by approximately 0.2 mm. EDS determined that the deposited material was tungsten metal. In addition, deposition also occurred on the outer surface of the orifice plate, as indicated by the slight rises on the orifice plate surface. The photograph in Fig. 31 shows that the inner surface of the orifice plate was roughened severely by discharge operation, probably due to removal of the thoriated tungsten and deposition of insert material removed from the upstream surface. The roughness increased with distance from the orifice. At the outer edge of the visible range of the plate, there were large formations of deposited materials which had a crystalline appearance. Material composed of barium, aluminum, tungsten and oxygen, which was probably an oxide, was also found deposited on the orifice plate. This compound is distinguished in the BSE photograph in Fig. 32 as the darker material that seemed to be coating the tungsten formations. Distribution of the compound peaked midway between the orifice and the cathode insert, with coverage being lightest near the orifice plate. The lighter areas in the photo were composed primarily of tungsten, with trace amounts of barium, aluminum, and molybdenum.

Figure 30. SE image of the orifice and downstream end of the insert of cathode TL-I. Propellant flowed from bottom to top.

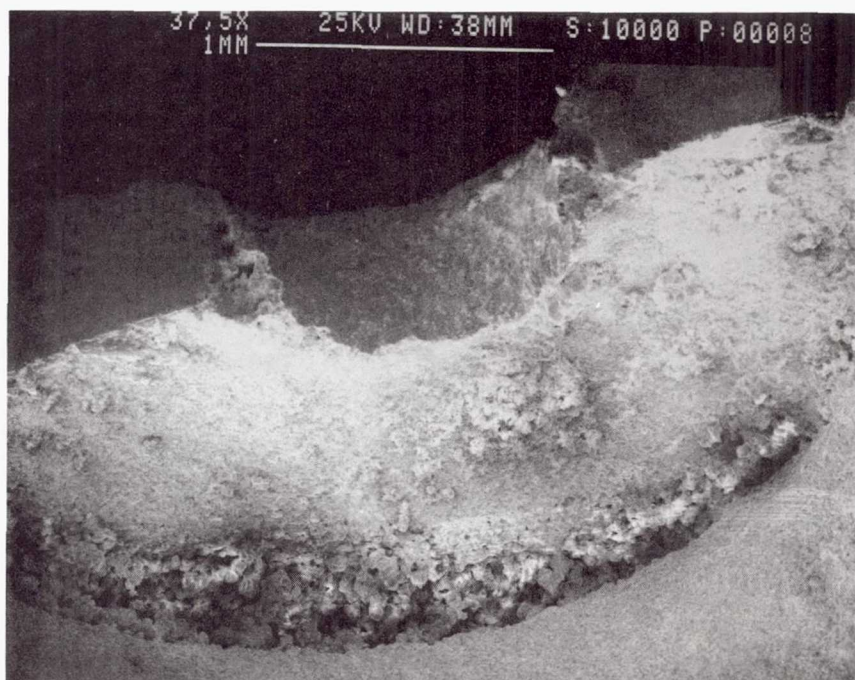
Figure 31. SE image of the inner surface of the cathode TL-I orifice plate. Propellant flowed from bottom to top.

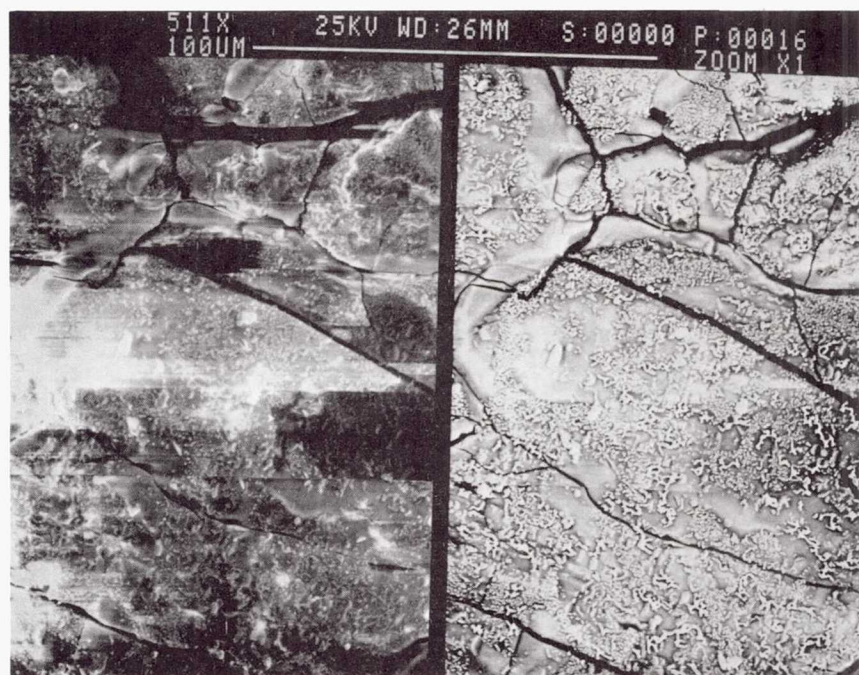
Fig. 36 shows a photograph of the surface of the third insert region. Large layer formations, which were composed of tungsten, barium, and oxygen with trace amounts of molybdenum, aluminum, and rhenium, covered the surface. Charging of the surface during examination indicated that it was nonconductive. The composition and behavior was similar to analogous layer structures seen in the SBJ1 wear-test cathodes and, as such, was assumed to be an oxide. The coverage of the surface material was nearly complete at the upstream end and small tungsten structures were scattered on top of the layer.

Figure 36. Surface of third region of the cathode **TL-I** insert.

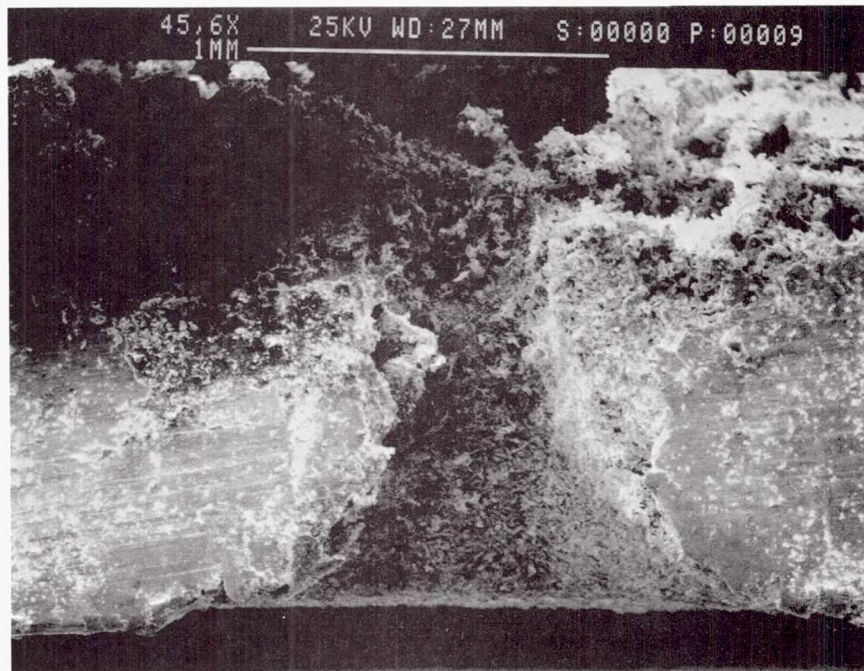
For the neutralizer cathode TL-II, the internal surface conditions were similar to cathode TL-I, with some differences. Fig. 37 shows a photograph of the orifice region. The chamfer and channel were substantially altered and showed deposition of material over both surfaces in a rough, grainy layer. The deposited material, which was determined by EDS to be tungsten, did not have the solid appearance of the orifices in the rest of the cathodes. The upstream side of the orifice plate suffered extensive damage and deposition of material. The entire inner surface was covered with deposited material as shown in the photograph in Fig. 38. The larger structures in the photograph were crystalline formations of tungsten metal. Compounds which were suspected of containing barium were found on this surface, among the tungsten formations, as indicated by the gray areas in Fig. 39.

Figure 37. SE image of the orifice region of cathode TL-II. Propellant flowed from top to bottom.

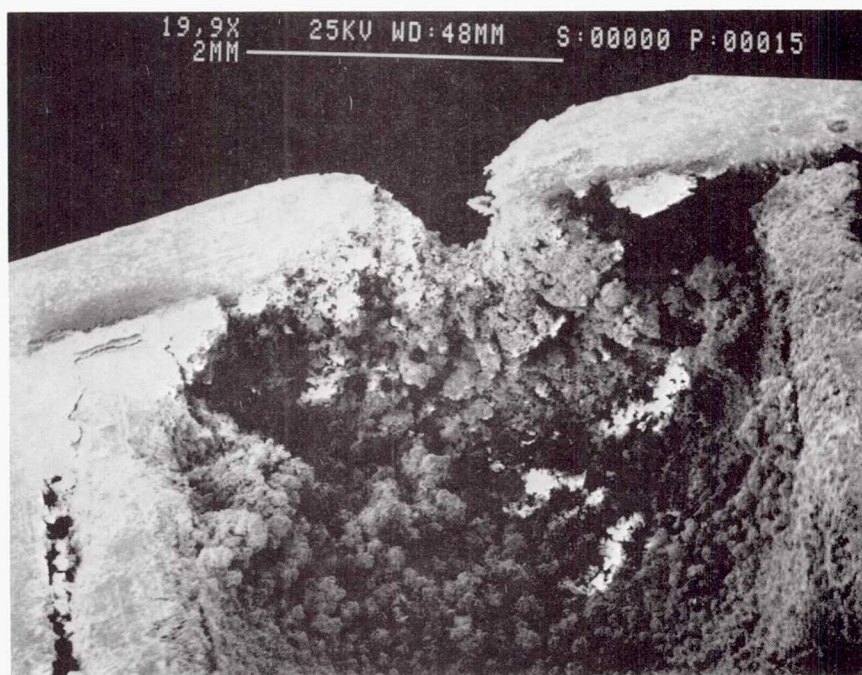
Figure 38. SE image of inner surface of the cathode TL-II orifice plate. Propellant flowed bottom to top.

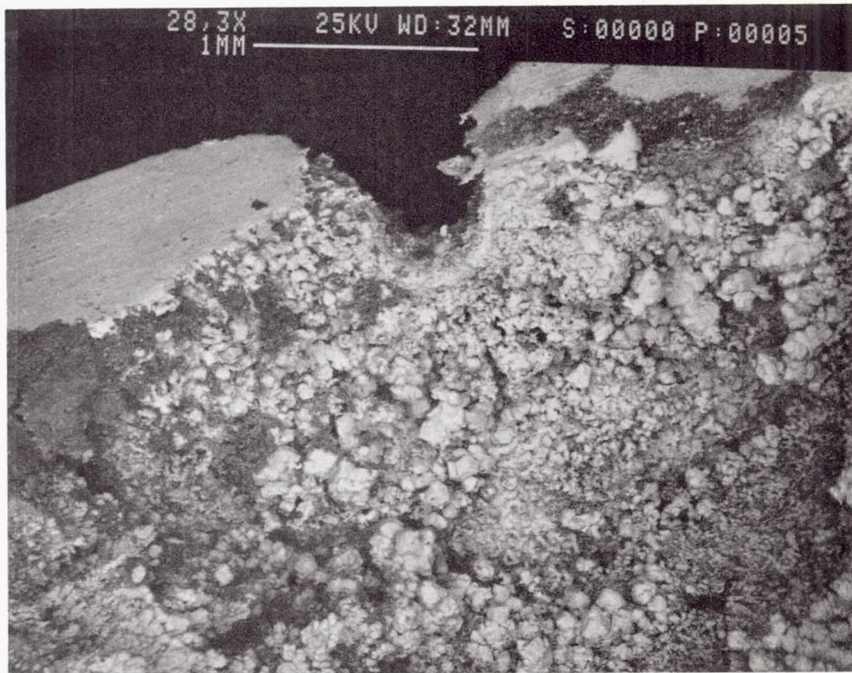
Figure 39. BSE image of inner surface of the cathode TL-II orifice plate. Propellant flowed bottom to top.

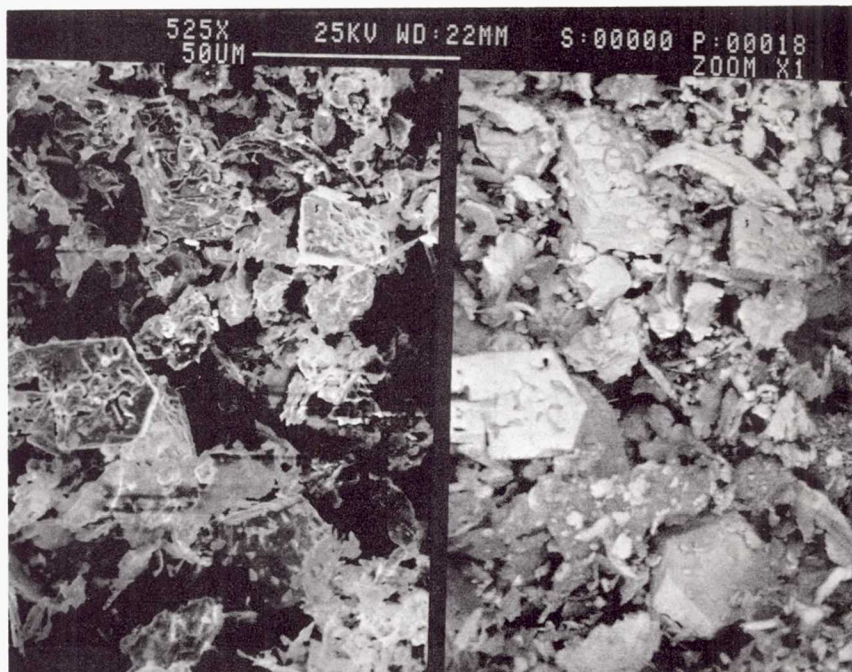
the region immediately next to the orifice was extremely rough, as can be seen in Fig. 40. The BSE image shows that the surface material was relatively homogeneous and EDS determined it to be tungsten. This region extended approximately 0.3 cm upstream of the orifice and was probably the region where the chunk of tungsten, formed as a cap over the orifice, was located inside the insert. This plug had a diameter of approximately 3.2 mm and is shown in Fig. 41.

Figure 40. Surface of first region of cathode TL-II insert.

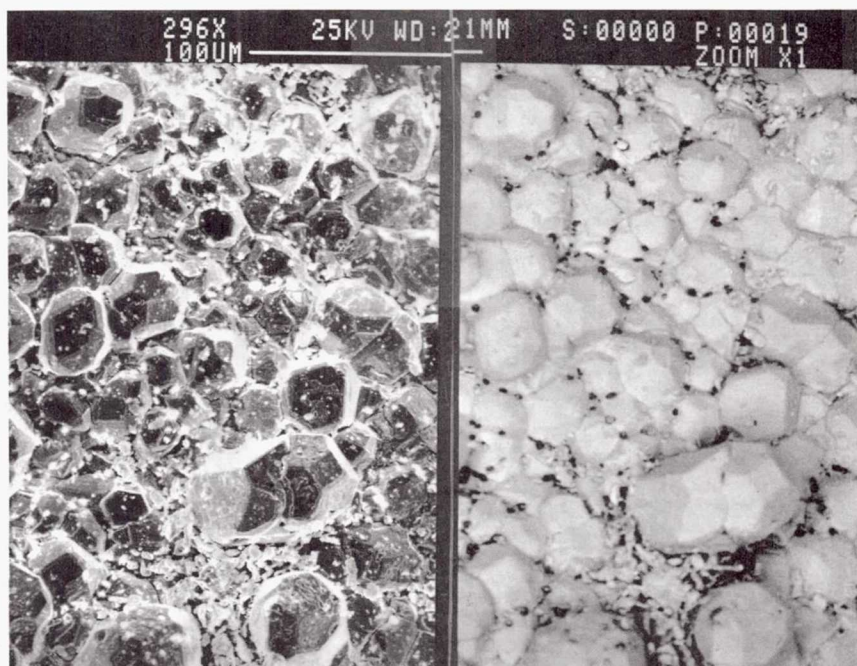
The remaining area of the insert surface was divided up into two regions (see Fig. 20). Upstream of the crystalline formations, the surface was composed of rough granular structures which were found to be primarily tungsten, with trace amounts of barium and aluminum (Fig. 42). In this region of the insert, a nonconductive material was found to have filled the insert-cathode tube gap; probably formed from impregnate migrating out of the insert pores. This material may account for affixing the insert in the cathode tube, like cathodes WT-I and TL-I. The white appearance of the material in the image on the left of Fig. 43 indicated that the material was charging. EDS determined that the material was composed of tungsten, barium, oxygen, and trace amounts of calcium, molybdenum, and aluminum. The BSE image shows the gap material as darker than the wall materials, which indicated that the compound was probably an oxide.

Figure 42. Surface of second region of the cathode TL-II insert.

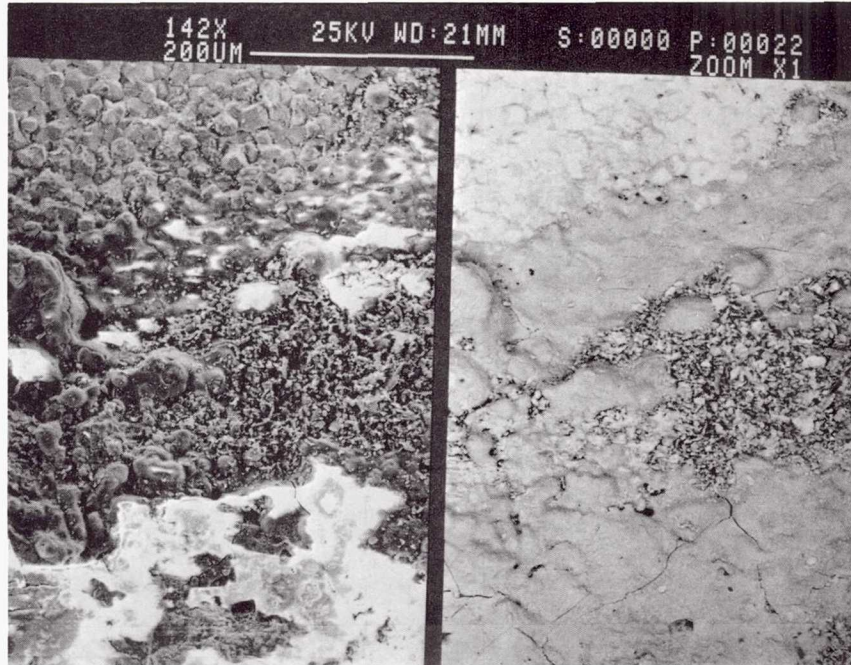
The final region of the insert surface was covered with a uniform layer, composed of tungsten, barium, calcium, and oxygen. The photograph in Fig. 44 shows the boundary where the surface coating began. It was very homogeneous under BSE and was similar to other layer formations observed on the other inserts. On top of this layer, small tungsten structures were found scattered. The nonconductive portions of this layer were not symmetric over the insert surface and neighboring regions of the layer did not charge under secondary electron emission even though they were composed of similar material. These layer structures were present to the end of the insert, but different elements were included in its composition. The tungsten grains on the surface became more numerous away from the boundary. Near the upstream end of the insert, the primary elements were molybdenum, rhenium, and small amounts of tungsten, barium, oxygen, and calcium. The composition changed again in the region next to the molybdenum collar

Figure 44. Surface of third region of the cathode TL-II insert.
